Executive Summary

The East Branch South Branch Kishwaukee River

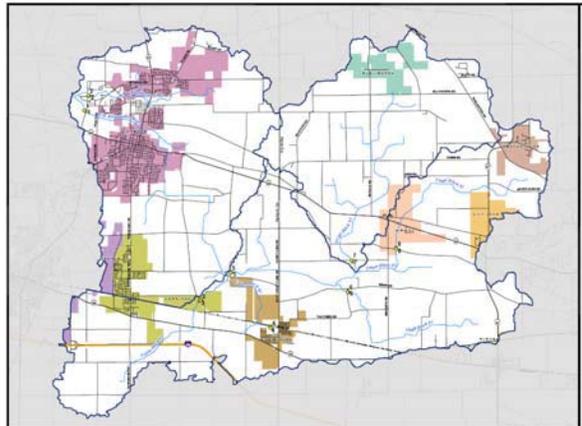
Figure 2: Watershed Map

The East Branch South Branch Kishwaukee River Watershed can be divided into 3 primary subwatersheds: Virgil Ditch, Union Ditch, and the East Branch South Branch Kishwaukee River (Figure 3-2). The Virgil Ditch subwatershed finds its headwaters in northwestern Kane County and flows south into Union Ditch. The Union Ditch system generally flows west from Kane County into DeKalb County and flows into the East Branch South Branch Kishwaukee River. As noted above, the East Branch South Branch Kishwaukee River is a major tributary to the South Branch Kishwaukee River.

Collectively, there are 72.7 stream miles in the East Branch South Branch Kishwaukee River Watershed: 21.3 miles attributed to East Branch South Branch Kishwaukee River, 13.7 miles of Virgil Ditch and 37.7 miles of Union Ditch. Available data indicates that 2,475 acres of wetlands are located within the East Branch South Branch Kishwaukee River watershed. There is one major surface impoundment in the watershed: Sycamore Lake. Sycamore Lake is 7.5 acres in size and is located within the East Branch South Branch Kishwaukee River subwatershed.

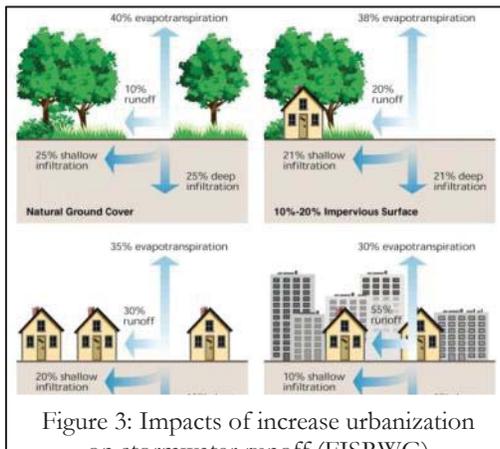
Figure 3: Impacts of increase urbanization on stormwater runoff (FISRWG)

Under natural and undisturbed conditions, precipitation that falls onto the land surface is allowed to soak into the soil and become groundwater in a process referred to as infiltration or evaporated into the air by plants or from soil or surface waters in a process known as evapotranspiration. Typically, 75-90% of the rainfall either soaks into the ground or evaporates. Precipitation that is not infiltrated or evaporated is called runoff. Urban development in the watershed is reducing the amount of land available for the natural infiltration of rainfall into the ground (Figure 3).

Instead of precipitation falling on vegetation where it can be infiltrated, it falls on parking lots, rooftops, and roads. The surfaces that prevent infiltration are known as impervious surfaces. From these impervious surfaces, the runoff is quickly conveyed into streams and creeks via a constructed drainage system comprised of drainage ditches, swales, and storm sewers. As a result, streams receive large pulses of water in shorter periods of time, resulting in erosion and destabilization of the stream channel and streambanks. As physical modification of the stream occurs, adjacent property can be damaged. Additionally,

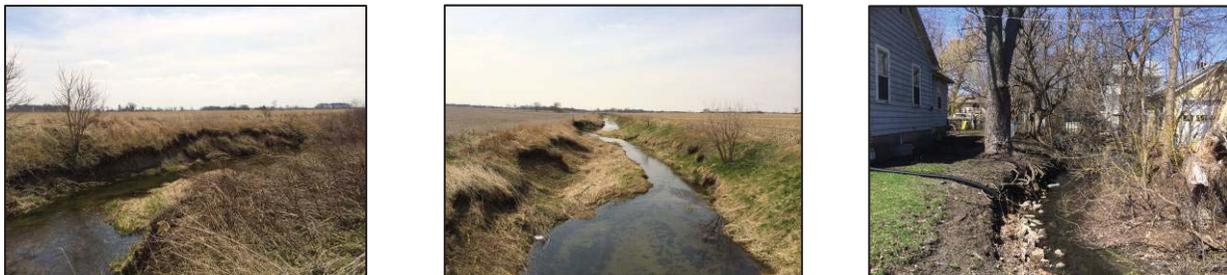
Figure 4: Photos of Watershed Concerns

Figure 4 below includes photos of problem areas identified in the watershed. Goals were drafted directly from the concerns expressed by the Watershed Steering Committee members and watershed stakeholders. The final goals were adopted on October 9, 2013 meeting and capture the desired outcomes and vision for East Branch South Branch Kishwaukee River (including Union Ditch and Virgil Ditch) watershed. Objectives assigned to each goal are intended to be measurable so that the DCWSC can assess future progress made towards each goal. The goals are not listed by order of importance.

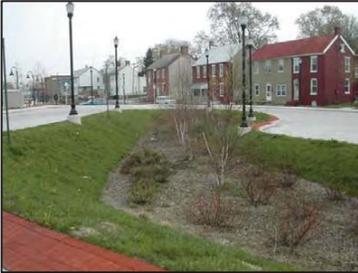
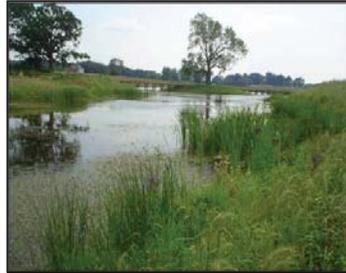
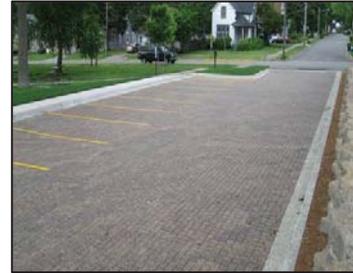
Figure 5: Examples of BMPs that could be implemented in the watershed

The effectiveness of the East Branch South Branch Kishwaukee River Watershed-Based Plan will be largely dependent on the successful implementation of the Prioritized Action Plan by watershed stakeholders. The Action Plan serves as a roadmap for watershed improvement and provides the “who, what, where, and when.” The Prioritized Action Plan includes programmatic, policy, and site-specific recommendations. Programmatic Actions are focused on watershed-wide action items that are not site specific while the Site Specific Action Plan identifies specific and actual locations where water quality, hydrological modification, and/or flood reduction/prevention projects can be implemented (Figure 5). The six most important general recommendations include:

- Stabilizing and restoring streambanks using bioengineering techniques.
- Installing rain gardens and bioinfiltration practices to help slow, infiltrate, cool, and cleanse stormwater runoff before being discharged into stream.
- Constructing new and retrofitting existing detention basins to help reduce volume and rate of stormwater released during storm events into streams.
- Reducing the area of impervious surfaces and using permeable pavements that allow water to infiltrate into the ground instead of running off as stormwater runoff.
- Restoring and maintaining native riparian buffers along stream and detention basins.
- Creation/restoration of wetlands to help slow, infiltrate, cool, and cleanse stormwater runoff before being discharged into stream
